Manhole Inspection Summary

Manhole # S49CC_050MH

Record Plat: **49CC** Node: **050** Status: **Found**

Insp Date: **6/16/08 9:27 AM**

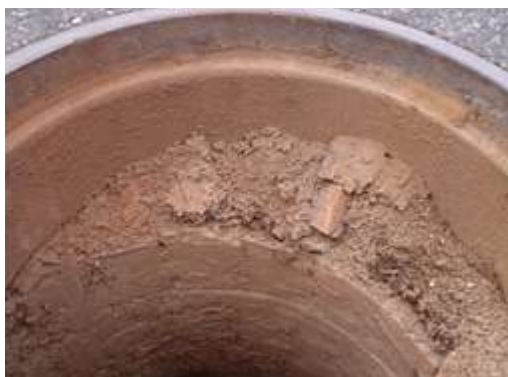
Defect 1

Infiltration: ☐ None ☐ Joint ☐ Cracks ☐ Mortar ☐ Roots ☒ **Wall**

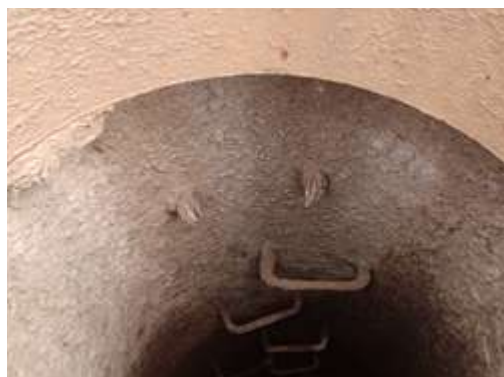
Defect 2

Count: **7** Missing: **0** ☒ **Corroded**

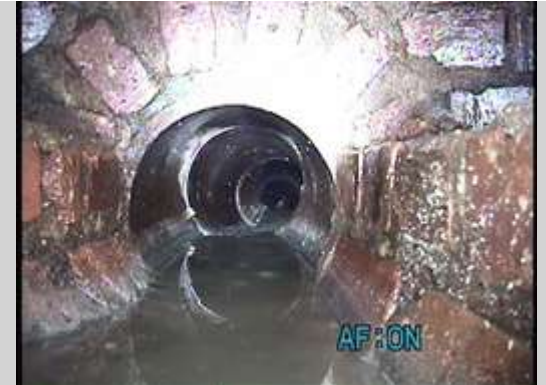
12 O'Clock Outflow

8 in. Circular Gravity Sewer
Pipe Out @ 12 O'Clock

Pipe Height: **8.4** (in.) Rod and Bar (Angled)
Pipe Material: **Clay** ☐ Pipe Lined
Invert Depth: **11.95** (ft.) Flow Characteristics: **Slow**
Deposits: ☒ None ☐ Mud ☐ Sludge ☐ Debris ☐ Grease
Silt Depth: (in.) Deposits Extent:
Infiltration: **None** Pipe Seal Cond: **Sound**

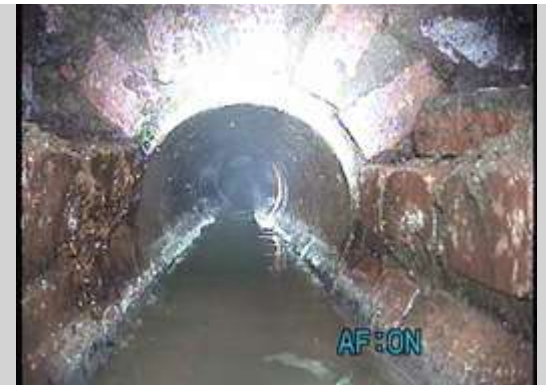
6 O'Clock Inflow

8 in. Circular Gravity Sewer
Pipe In @ 6 O'Clock

Pipe Height: **8.4** (in.) Rod and Bar (Angled)
Pipe Material: **Clay** ☐ Pipe Lined
Invert Depth: **11.90** (ft.) Flow Characteristics: **Slow**
Deposits: ☒ None ☐ Mud ☐ Sludge ☐ Debris ☐ Grease
Silt Depth: (in.) Deposits Extent:
Infiltration: **None** Pipe Seal Cond: **Sound**

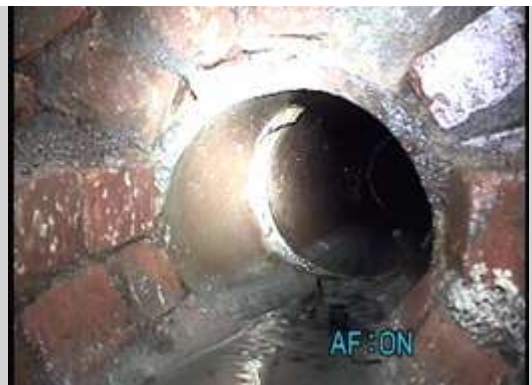
9 O'Clock Inflow

8 in. Circular Gravity Sewer

Pipe In @ 9 O'Clock

Infiltration: **None** Pipe Seal Cond: **Sound**
